Bearhawk #164 “Three Sigma” Checkout Report

Date: 21-23 Mar 08

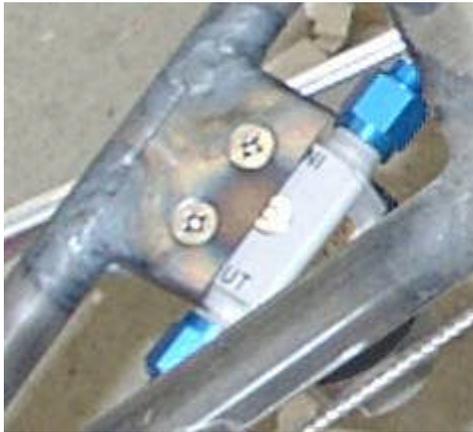
Background: Occasional whiffs of avgas smell were still occasionally noticed inside the fuselage. When the floor was removed for inspection, the top of the gascolator was moist and stained. A pipe plug was installed in the top center of the gascolator. This plugs a port provided for supplying fuel to a manual primer pump.

The internal wrenching plug's hex socket was found to be full of fuel. Inspection of the plug and thinking back placed a high probability that this plug was never properly installed with sealant or torqued.

Note in the picture above that the gascolator bracket partially covers the pipe plug. It was originally thought that there would never be a need to access this plug. Things didn't

work out that way. Since the gascolator would need to be removed to fix the fuel seep, this was a good time to address this limitation.

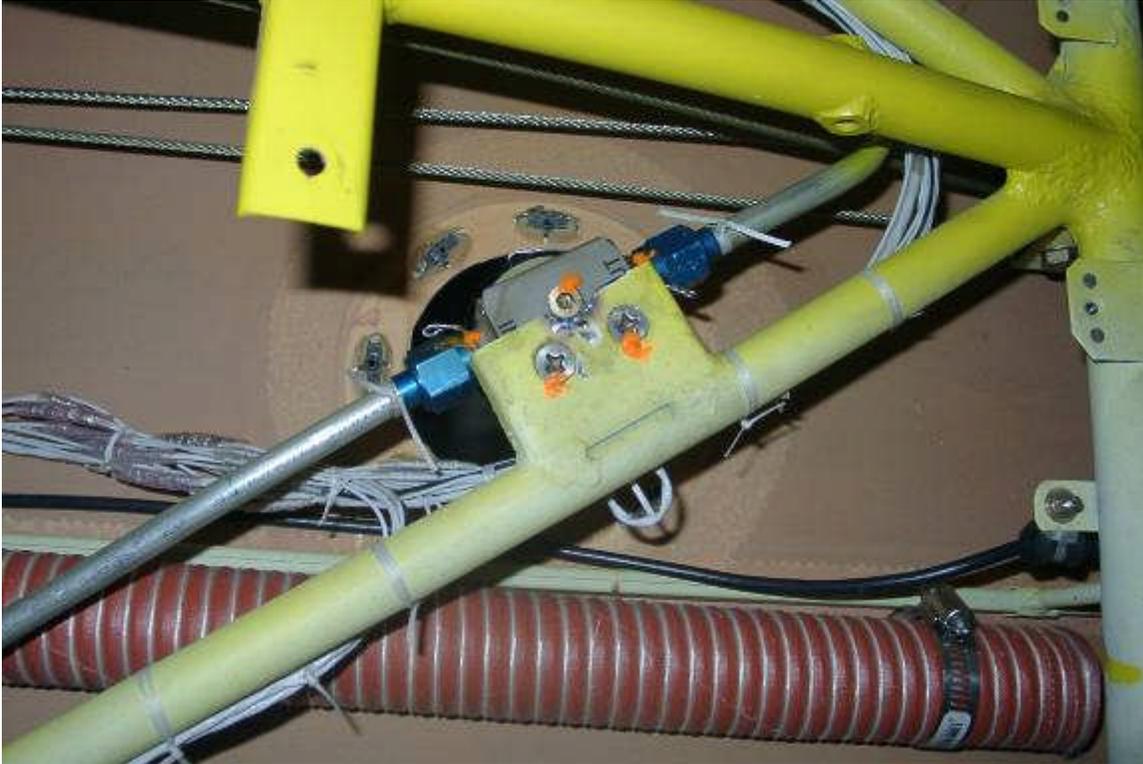
The repair was accomplished according to the procedure. There's something exciting yet disconcerting about grinding steel with bright little sparks going everywhere right next to a fuel line, even if the line has been drained and plugged with a fitting. Inspection the next day showed no sign of fuel leaks.

The lacing cord tied around the fuel line doesn't hold anything. It is there to detect fuel seeps. If the cord becomes stained blue, that will indicate a fuel leak.

Recommendations: Keep eyes and nose peeled for possible further indications of fuel seeps.

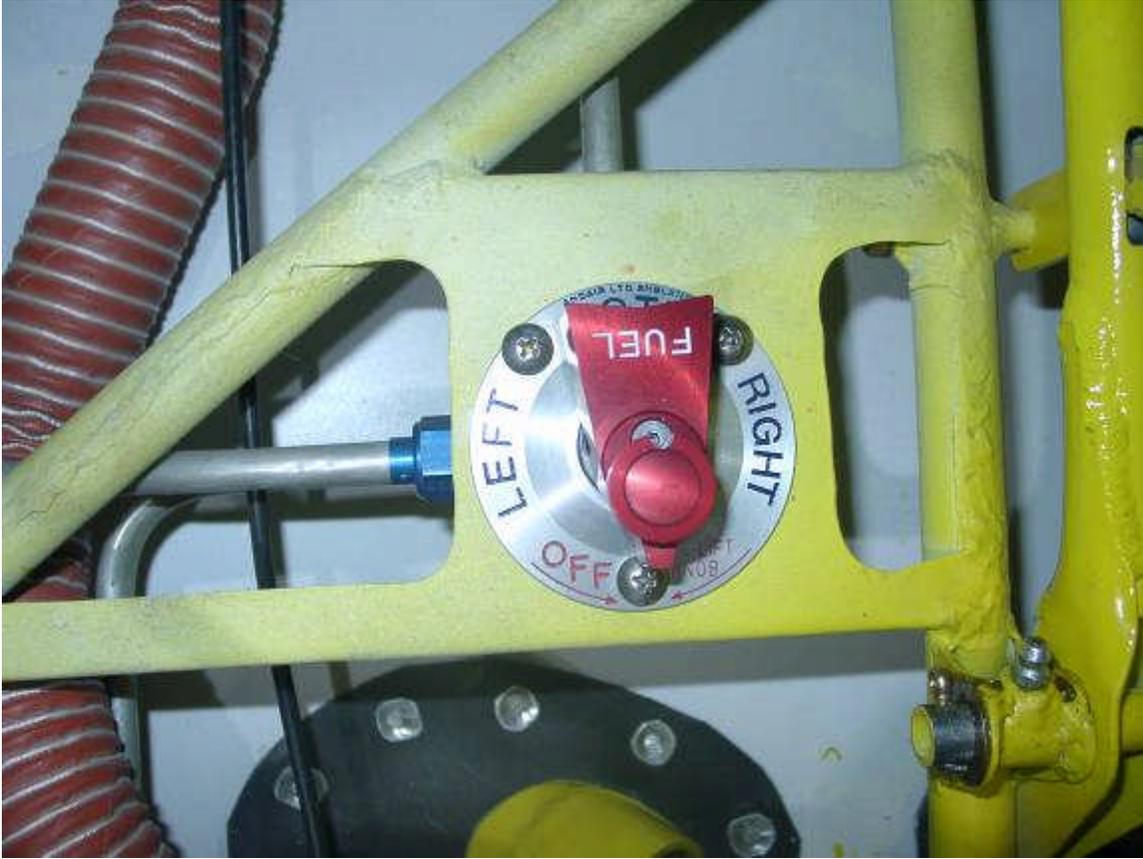
Done. The locking button on the fuel selector handle had previously been modified with a round file to allow direct access by any hex wrench instead of requiring the shortened hex wrench (special tool) that came with the fuel selector.

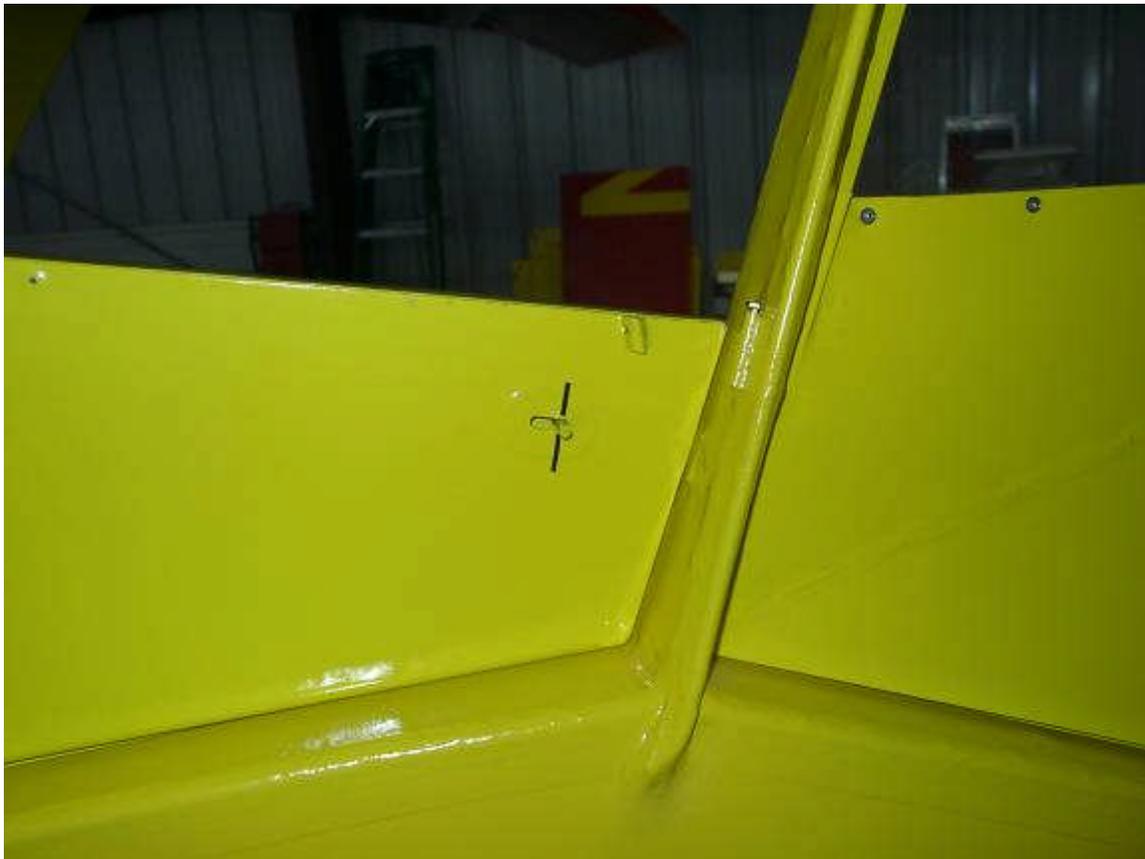
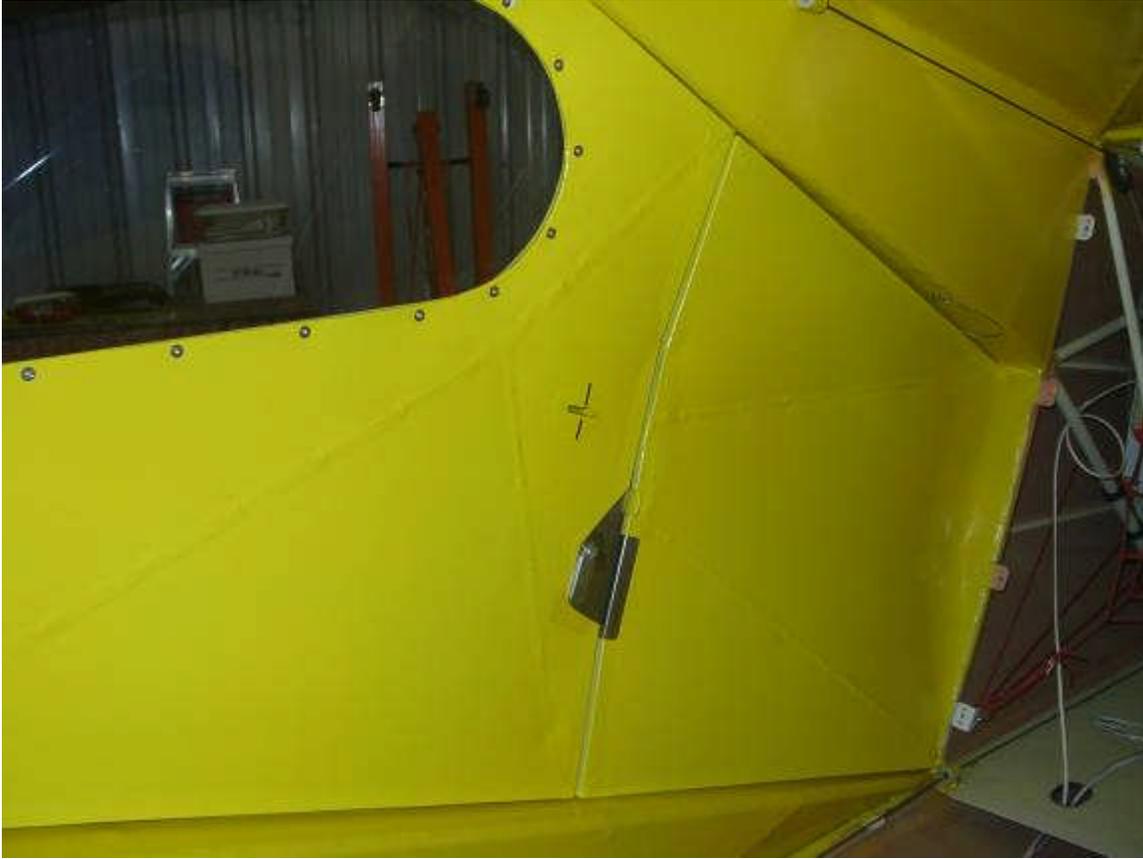
Stripes were applied to the doors to align with the door handles (latches) in the fully closed position. These stripes were 1/8" wide striping tape.

These stripes allow the pilot to visually verify that each door is properly latched prior to takeoff for safety. The door is latched if the handle is aligned with the stripes.
