Bearhawk #164 “Three Sigma” Checkout Report

Date: 23-27 Apr 08

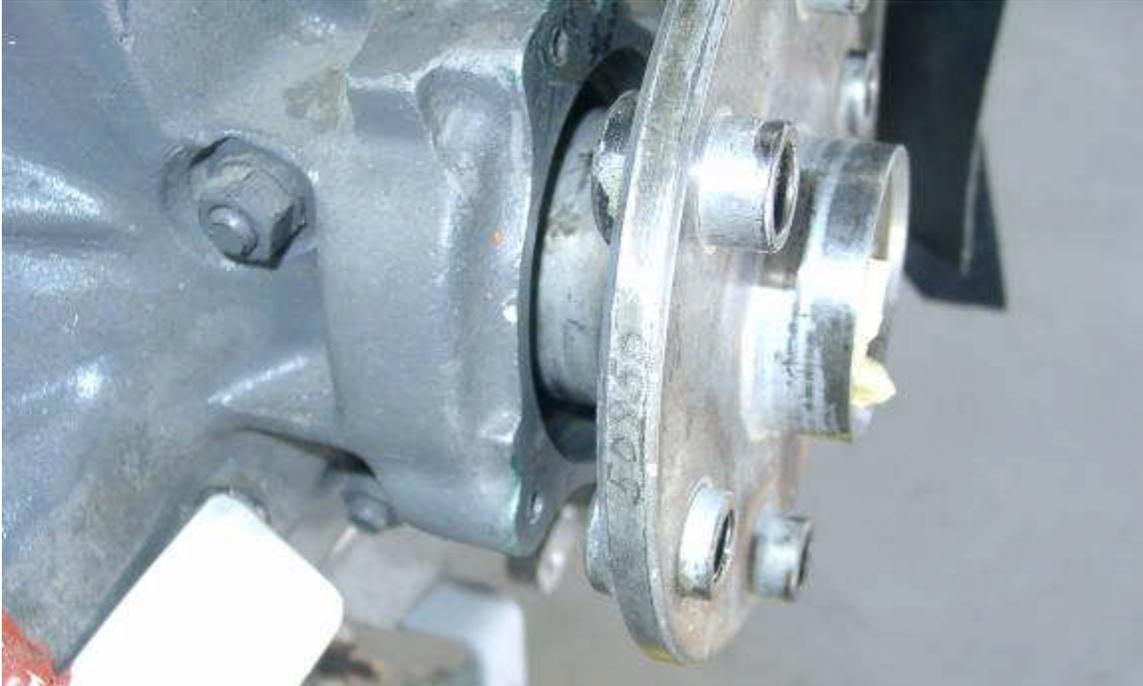
The cowling was removed. The spinner, propeller, ring gear, and Lightspeed direct crank ignition pickup board were removed. A drip pan was in place to catch the oil that came out of the propeller hub as the propeller was removed. As expected, the cavity for the front crankshaft oil seal was noticeably vacant.

Apparently the seal was left out during the overhaul. As the overhauler was in Indiana, there was no point in taking this back to the overhauler. Two crankshaft oil seals were included in the bag o' gaskets that came with the engine. No reason is known for why the seal was left out.

The front crankshaft oil seal was installed. Testing will be at the next engine run.
