Bearhawk #164 “Three Sigma” Checkout Report

Date: 6 May 08

Objective: Reinstall split nose bowl. Characterize the induction pressure losses through the carburetor airbox and air filter. Governor RPM check. Validate full throttle fuel flow. Characterize the induction pressure losses through the carburetor heat system. Verify front crankshaft oil seal function. Idle mixture check. Compression check.

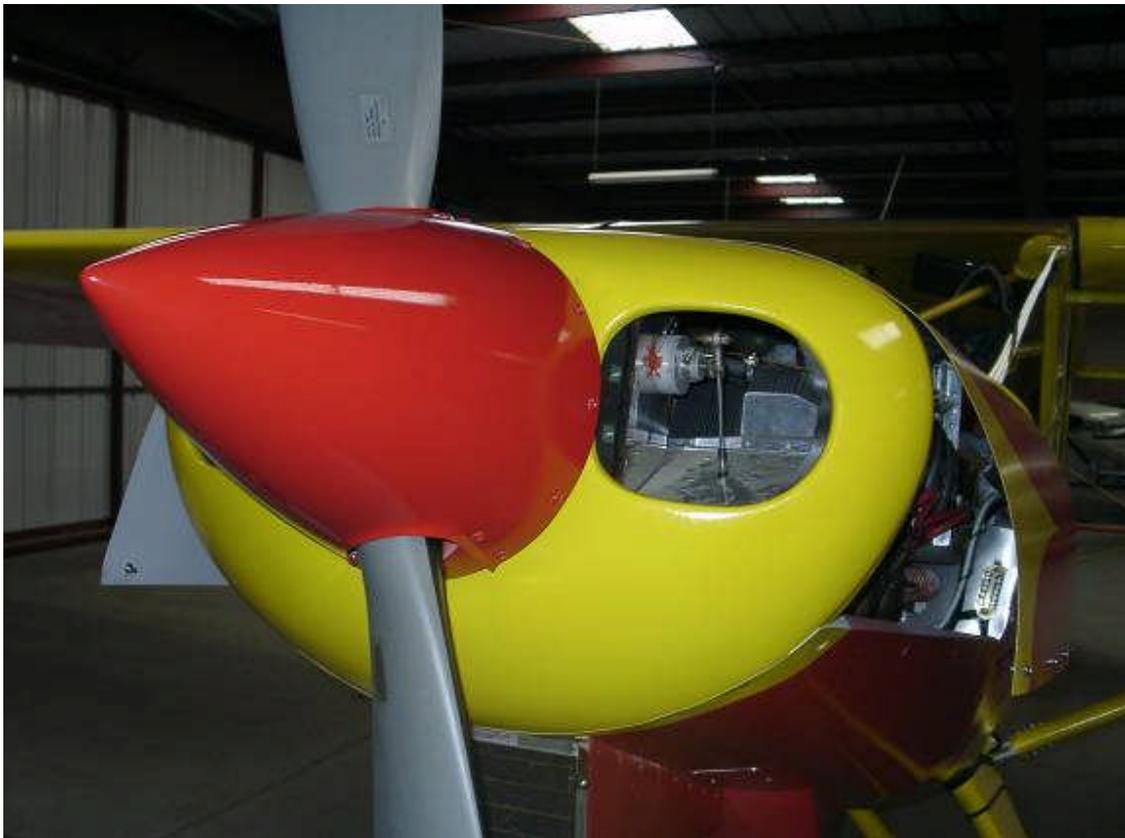
Background: With the unsplit nose bowl arthroscopic surgery techniques were required to safety wire the propeller bolts. This was a huge dent in maintainability and considered unacceptable.

The initial reticence to split the nose bowl was primarily driven by the perceived inaccessibility of the inner webs. The spinner that came with the prop was several inches in diameter larger than the spinner on Proto I. This problem did not exist on Proto I, from which this nose bowl was recommended. This nose bowl had already been procured when a different nose bowl more appropriate to the Hartzell spinner was recommended.

Procedure: The solution to the inner webs was to place the screw to enter from the side instead of the front. To do this, additional fiberglass had to be added to maintain sufficient edge distance. The inner portion of the outer web was modified in the same fashion. The outer edge was secured by a flat head screw under the cowl doors.

A fiberglass flange was built up on the lower half of the nose bowl to hold the nutplates.

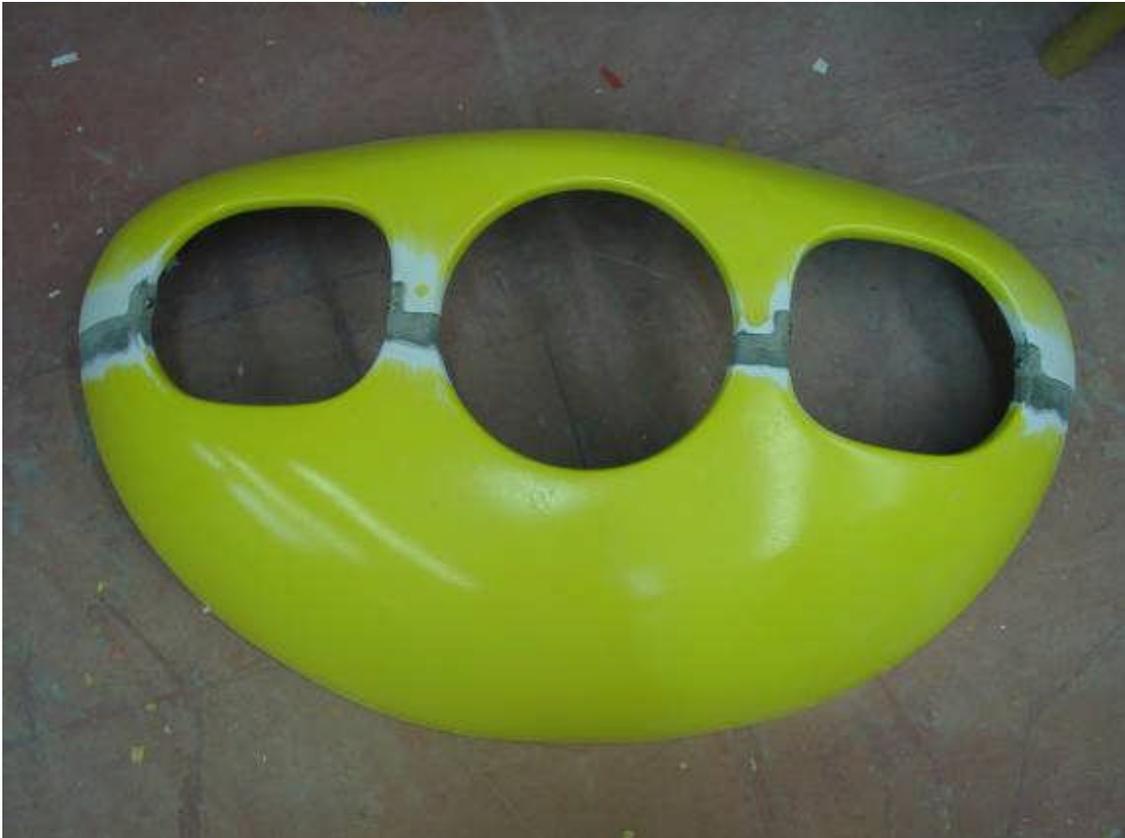
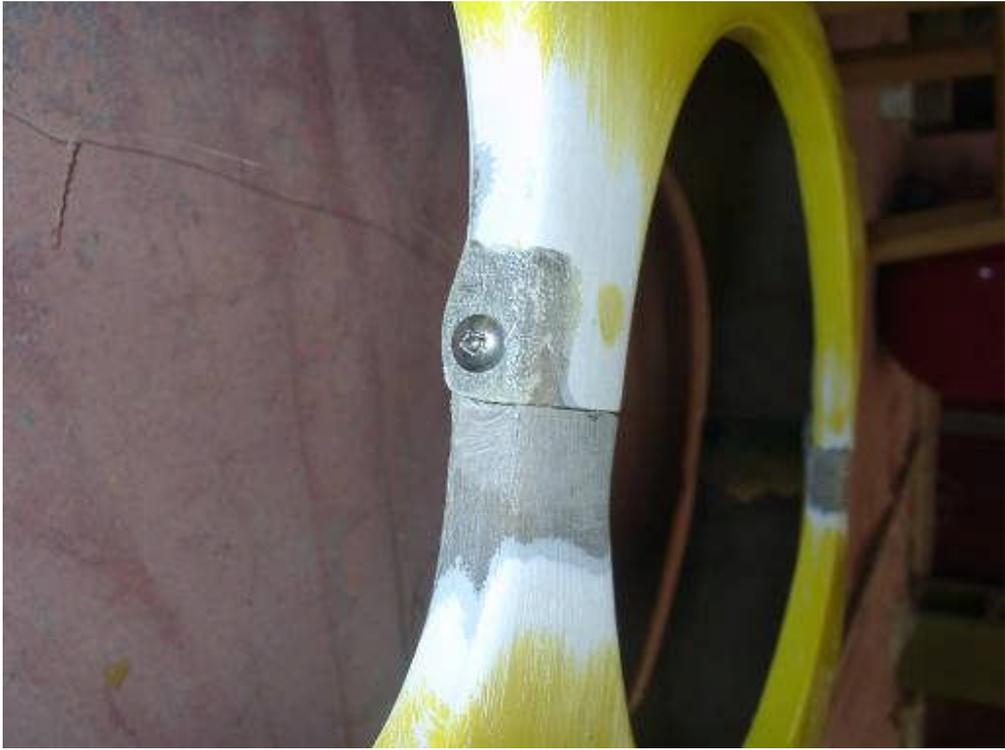
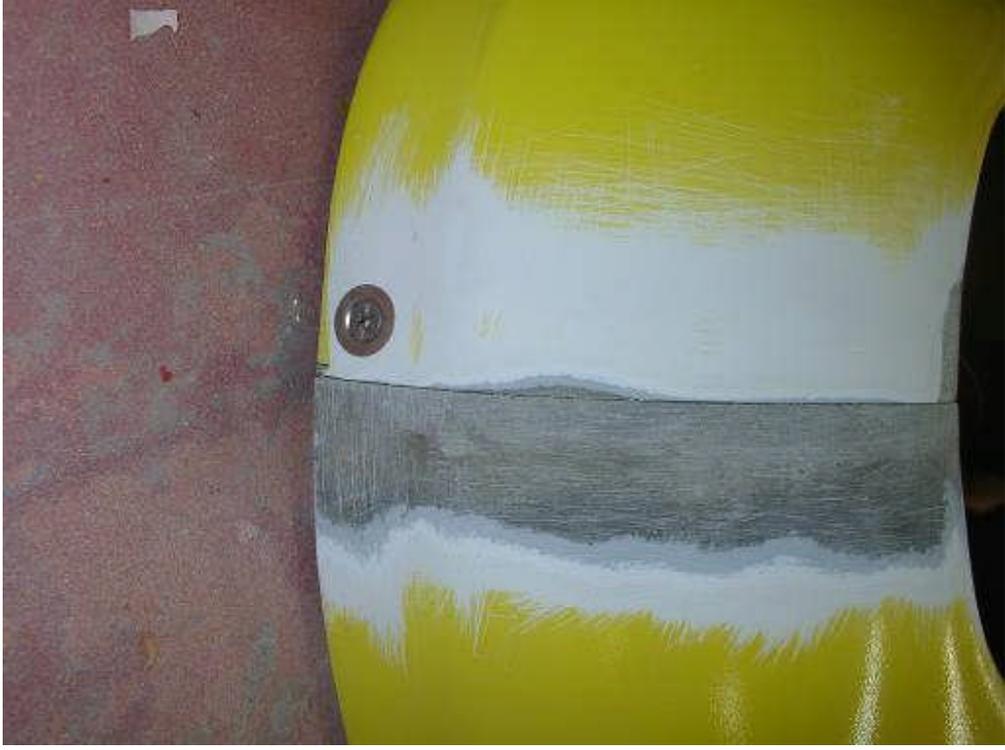
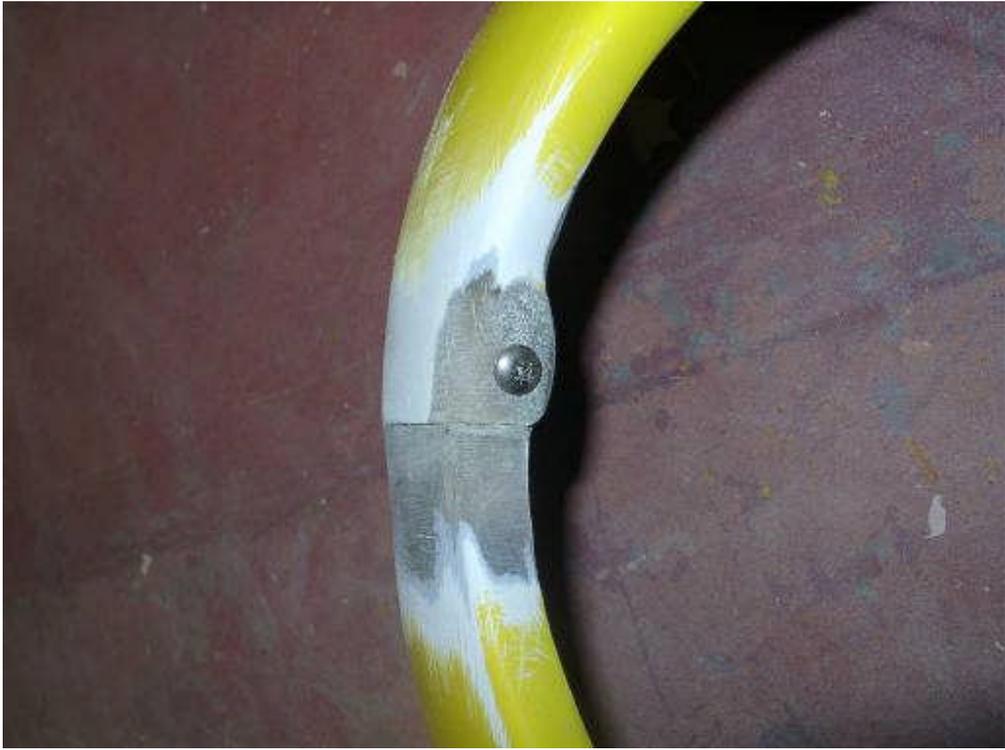
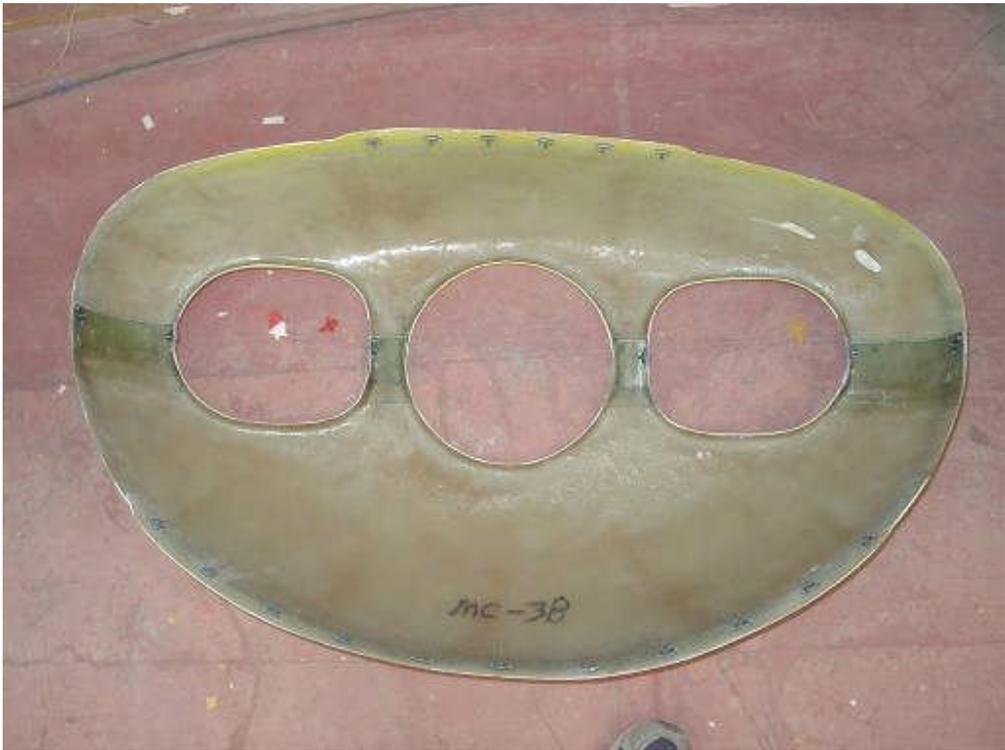
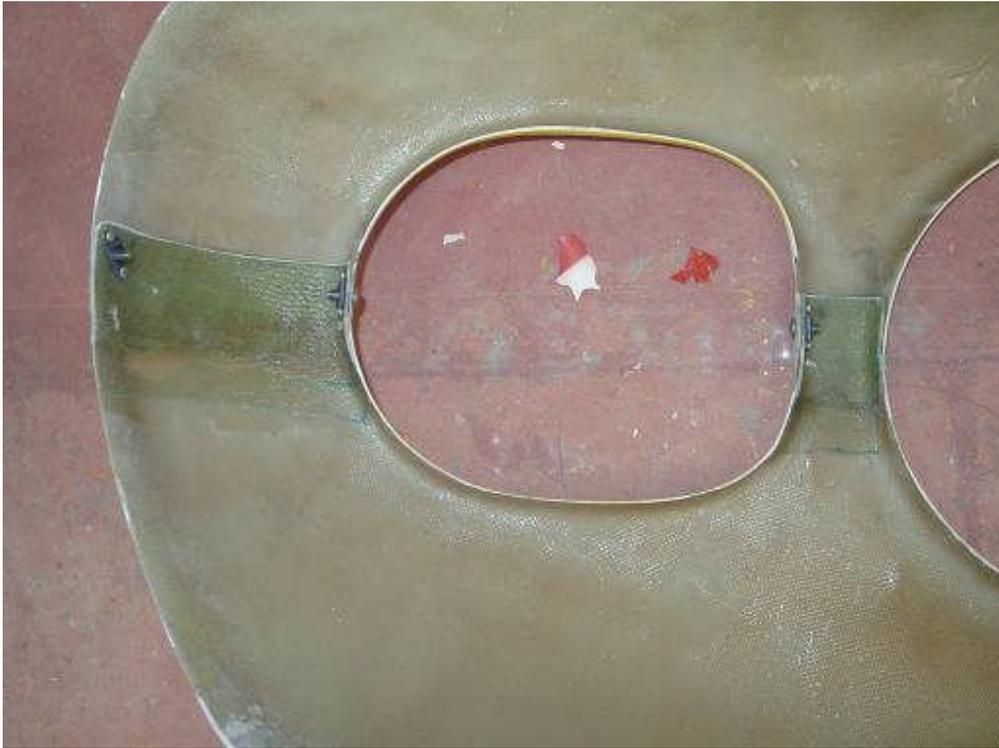
The finished modification. Later the finish will be removed and the surfaces re-contoured with glazing putty, followed by priming and painting.

The nose bowl was successfully re-installed on the aircraft. Even with just six screws the result was surprisingly stiff.

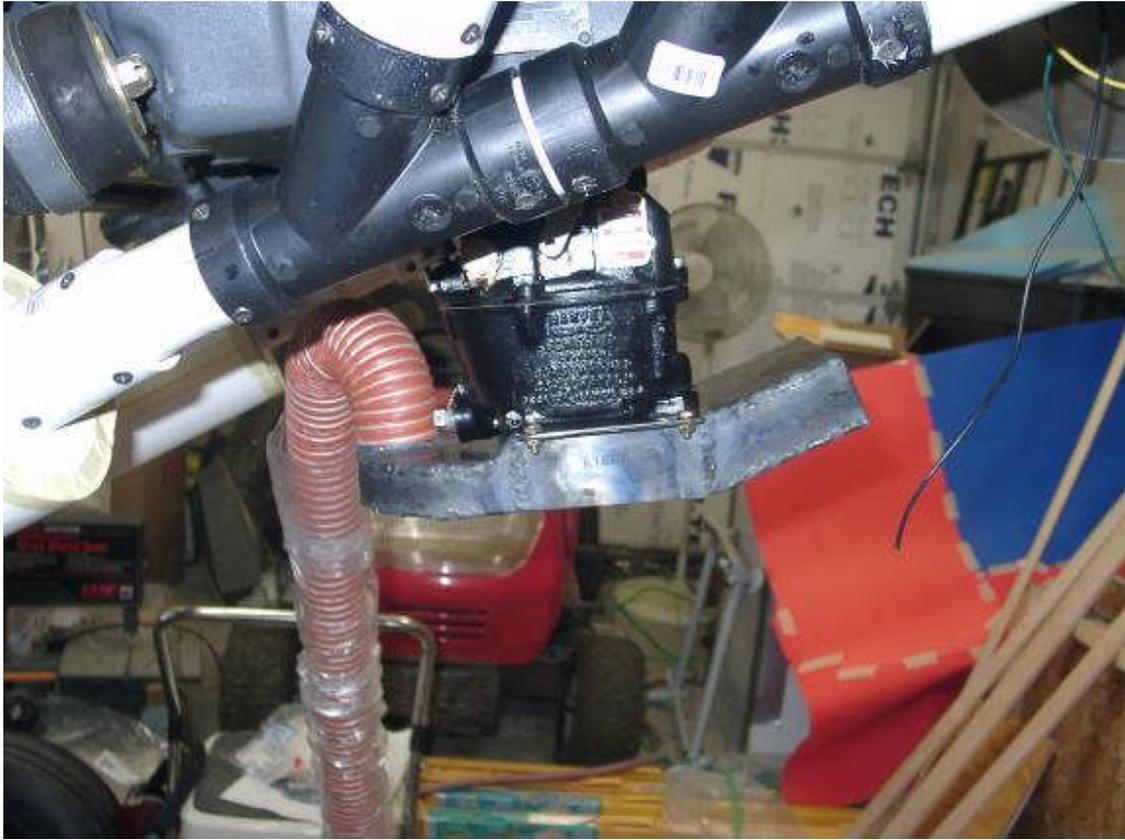
Several other EAAers had expressed concern that my low-profile carburetor airbox (of my own design) had too small of a cross-sectional area to properly supply air to the O-540. The airbox design had been designed to have a similar cross-sectional area as the 3 inch SCAT tube used on another design with a similar engine. The question that needed answered was how much pressure loss would happen through the airbox at maximum power.

The pressure drop through the carburetor and intake manifold was 1.3 inches of mercury. This would be the minimum possible pressure loss in the induction system.

Adding the air box resulted in an additional pressure loss of 0.1 inches of mercury. The air filter added another 0.2 inches of mercury pressure loss.

The pressure loss through the airbox is minimal and almost unmeasurable. The benefits to be gained by redesigning the airbox to a larger cross section are not significant enough to justify the effort required. **Leave the airbox as designed.**

Leave the airbox as designed.
